Shift Knob Feels Great, Looks Cool and Shortens Throw!

Install on 2014 C7

Install on 2017 GS

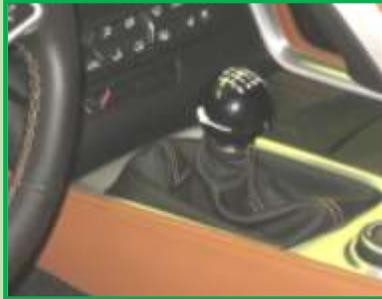
This “Cue Ball” size shift knob is available for the C7. Had the black one (left) on my Red 2014 Z51 C7 and installed the white knob (right) on my Artic White 2017 Grand Sport.

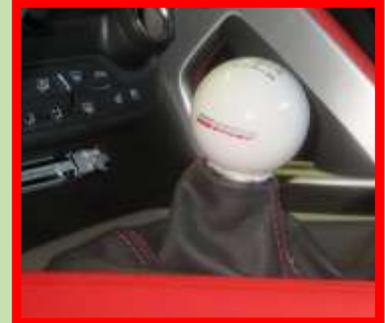
They are available in white or black with the 7 speed shift pattern and on the sides either Stingray image, the word Corvette and for my new 2017 Grand Sport.

The side Stingray image inlay is available in Red, Blue, Yellow, Silver, Black (for white knob), or White (for black knob, which is what I ordered.)

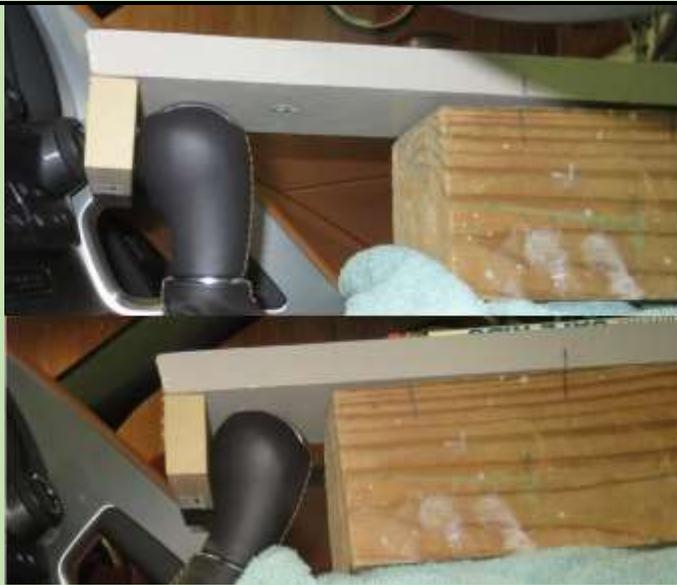
First task was to devise a way to measure the existing shifter throw. Decided since one often uses a cupped hand to pull the shifter back, the measurement method shown probably best defines the stroke. I used a section of wood that was perpendicular to the top board, simulating a cupped hand touching the knob. Marking the bottom block from the shift knob furthest forward to full back showed the standard shifter has a $2\frac{3}{4}$ inch throw.

Measuring the shifter throw with the new knob shows it was $2 \frac{7}{16}$ inches. That is $\frac{5}{16}$ inches less than the OEM shifter or $0.31/2.75 = 11.4\%$ less.

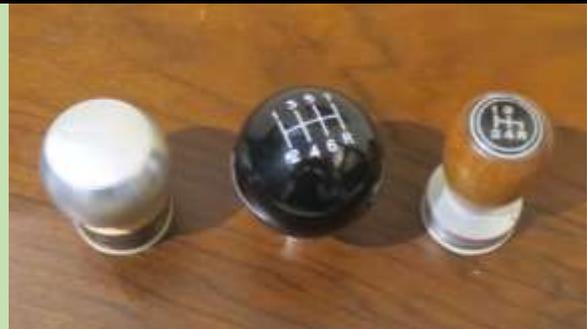
The knob is large, $2\frac{1}{4}$ inch diameter, the same size as a cue ball!

This picture shows a comparison with my desk paperweight knobs from my 1974 Datsun 260Z and a knob from a short throw B&M shifter installed in my S-10 truck some years ago.

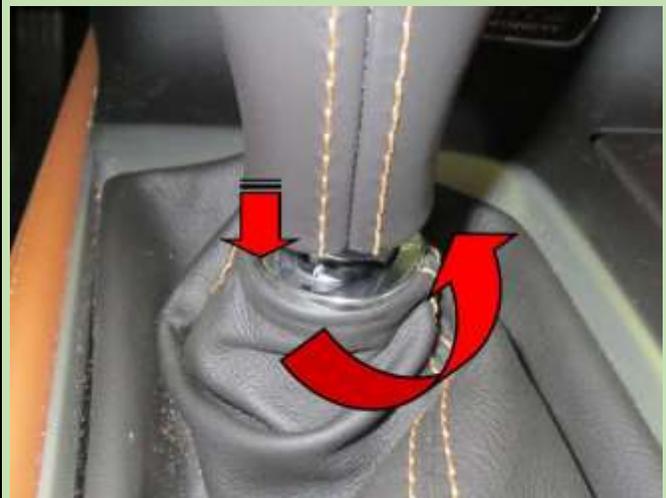
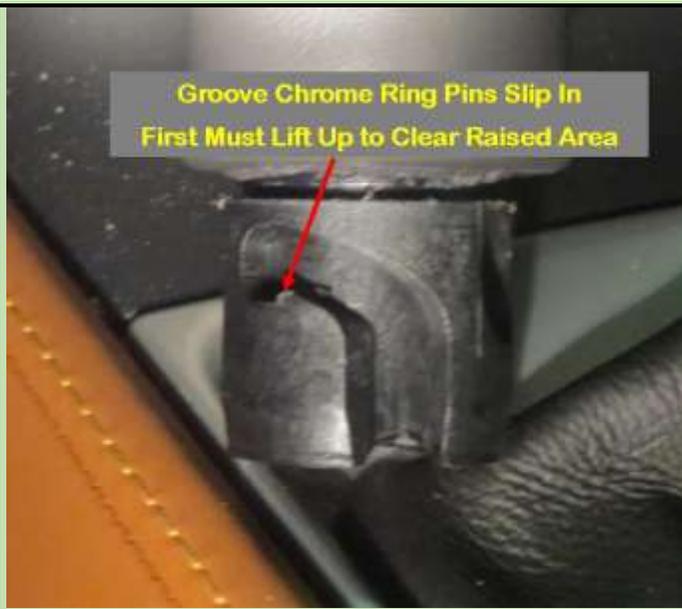
First, with the knob removed you can see the grooves that are on both sides of the OEM shift knob. That is the path two pins attached to the trim ring must follow it have it slide down to reveal the screw holding the knob in place.

There is a slight raised ridge (red arrow) that must be cleared before pressing the ring down in the groove. I think getting over that ridge was the problem I had because in my shifter the pins fit very tight in the grooves. Perhaps yours will have more clearance.

Now the tough part, removing the plastic (or what appears to be made of plastic) chrome trim ring that is attached to the top of the leather shift boot. Instructions and forum posts say you must pull-up, and then push down while turning counter clockwise. Easier said than done. Review the next few pics to see why! After 10 minutes of trying with various tools I went to YouTube and watched a video of a C6 knob removal that showed that the ring must be turned a full 90 degrees before it will slip down to expose the retaining screw. I had only been able to turn it 10 to 15 degrees.

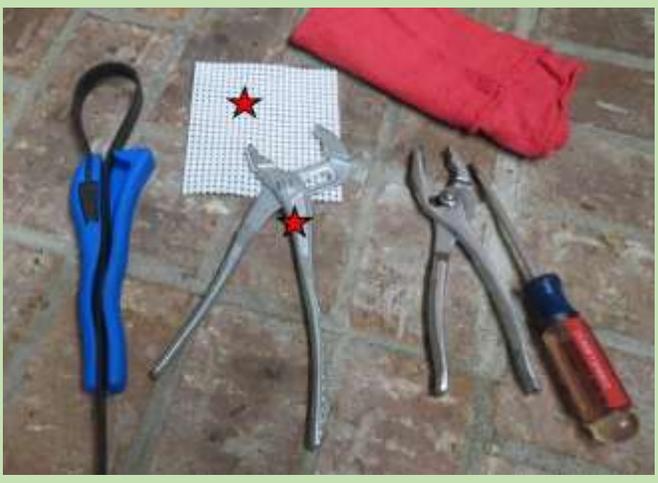
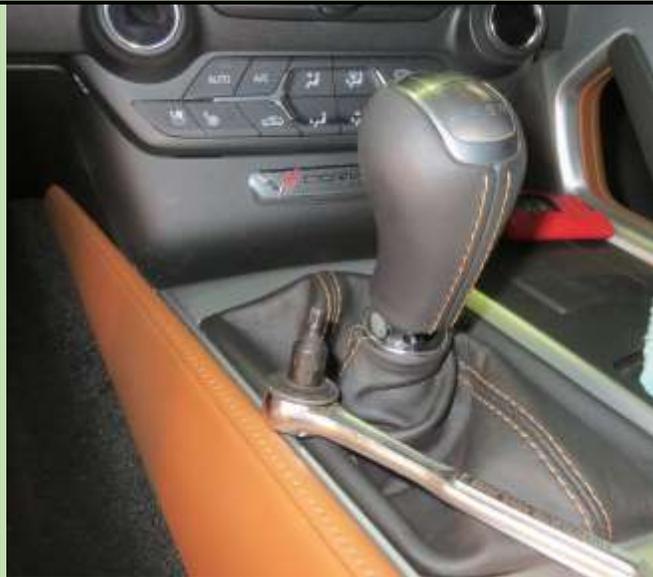
These are the tools I used trying to turn the trim ring! On the left is a rubber pipe wrench, which was not help. I even used a screw driver to leverage it down, don't do that, it won't help! Used a rag and the pliers shown next to the screw driver-no help. The best I could do was to get it to turn about 10 to 15 degrees when 90 degrees was needed!

Finally used the arc joint pliers (shown with the red star) and the jar friction pad (also shown with a red star.) The pad provided friction and well as protected the leather and chrome ring. It worked. Took quite a bit of force but it finally turned.

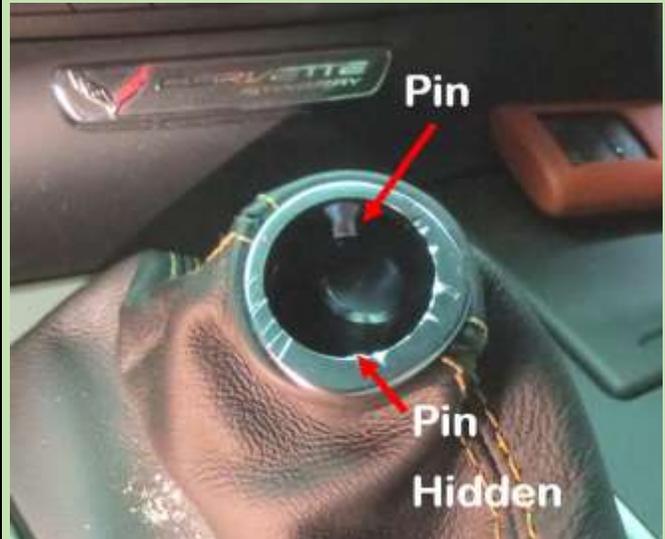
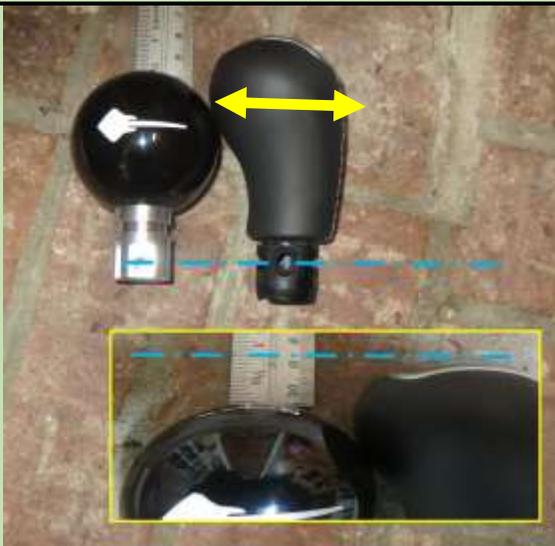
Once the trim ring was pulled down, removing the screw was easier than some instructions suggested. Used a T-25 Torx socket with a 1/4 inch drive ratchet wrench. Just placed my right hand on the shifter while turning the wrench with my left. It appeared to have Loctite on the screw but it came turned easily. Some forum comments said to drive the car until the shifter was hot, assume to weaken the Loctite. Thought I might have to heat the screw with a soldering iron tip, but that was not necessary.

After the OEM knob was removed, this pic shows one of the pins that is part of the ring. There is a similar pin (hidden from view in this pic) on the opposite side.

Considering I also had some difficulty reinstalling the trim ring, I could have used an emery board and sanded both pins slightly to provide more clearance. Perhaps your pins will be easier to slide in the grooves.

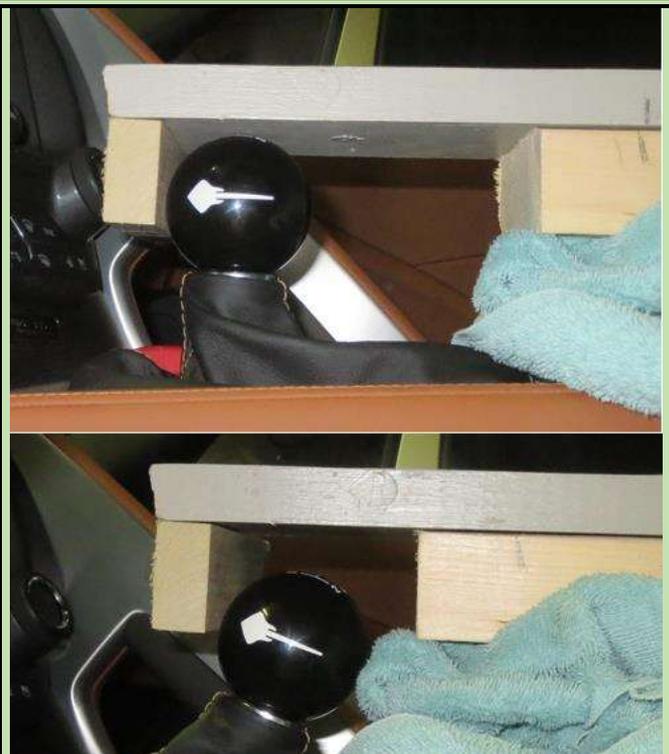
Once the knob is secured, the chrome trim ring is reinstalled. When fully up to the top it required the same arc joint pliers and the friction pad used to remove it, to rotate the ring in the final position. Not the best design especially since it appears it is only made of plastic.

Not the ~30% shorter throw of a specially designed complete new shifter, but much easier to install and less expensive! Note the short throw shifters still require removing the chrome trim ring!

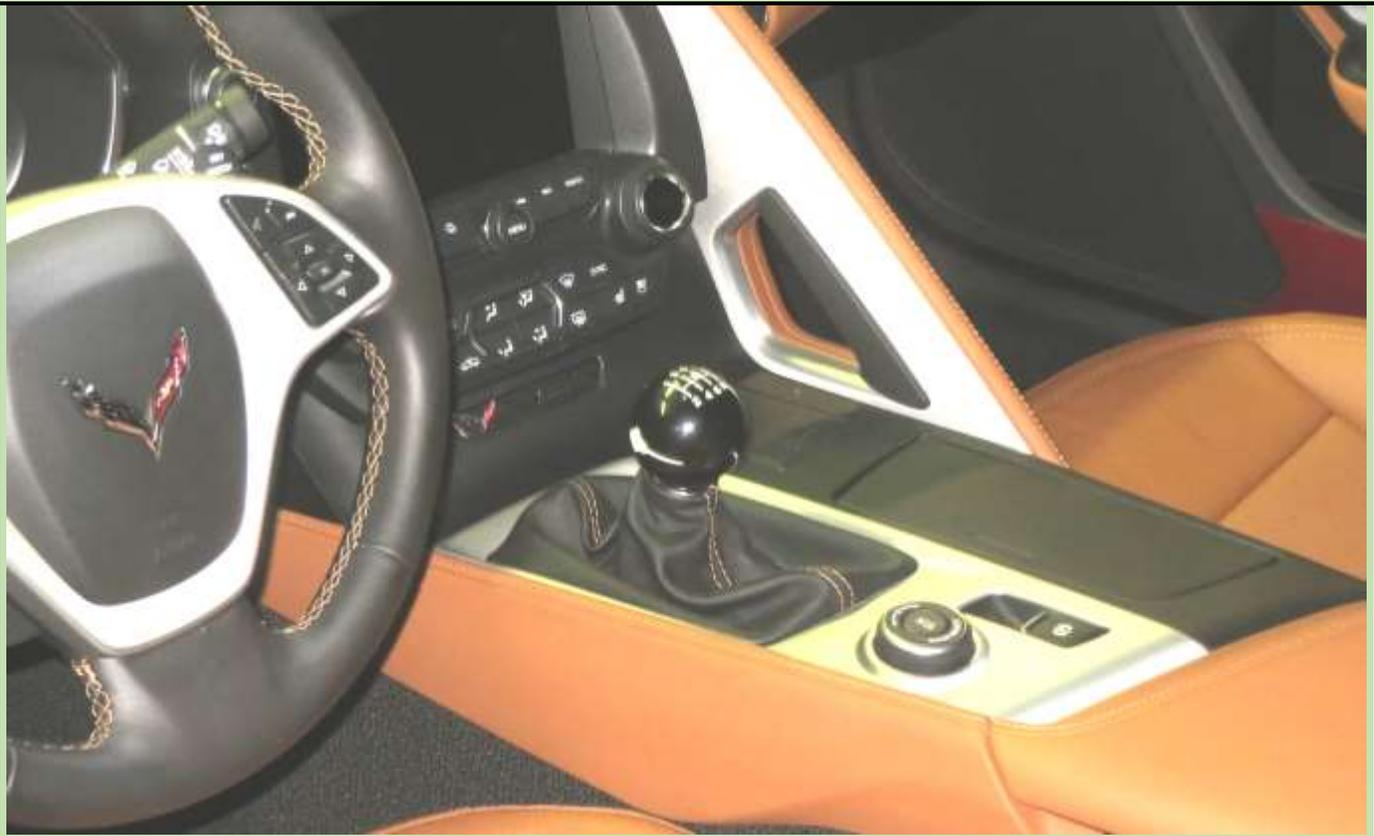
The final installation looks great. The black knob complements the interior trim.

After 7 months of use I defiantly would recommend this knob. It particularly makes the 4th to 5th shift and the 6th to 7th shift feel more positive. I also fine the 1st to 2nd shift when the trans is cold more positive as it does require more force until it warms up. 11.4% is not a lot of shift stroke reduction but it is noticeable. Someone questioned how the stock could be less since it didn't change the pivot point as is done with aftermarket shifters. I relayed what we did with column shift 3 speeds that I drive as a teenager! We would grab the lever close to the steering column and have a very short throw!

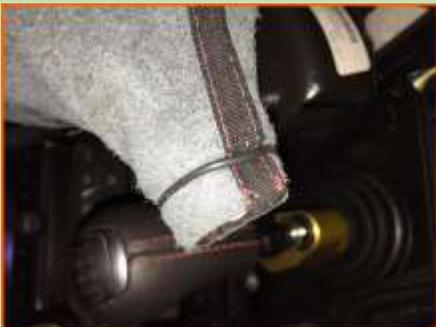
The leather boot is held to that plastic chrome trim with two small staples. I did not have this come loose but a he said his boot did. A responder stated: *"The staples come out very easily. Best fix is to take the shift knob off, then pop the entire boot off. Turn it inside out and use picture hanging wire to secure it to the chrome ring. There is a groove that the wire will fit in well."* After seeing the above note in this report, another forum member sent the pic left and said he found the metal ring shown holding the chrome trim ring. Appears there may be differences depending on year or production date.

Suggest you take care when pushing the ring down and it should not come loose.

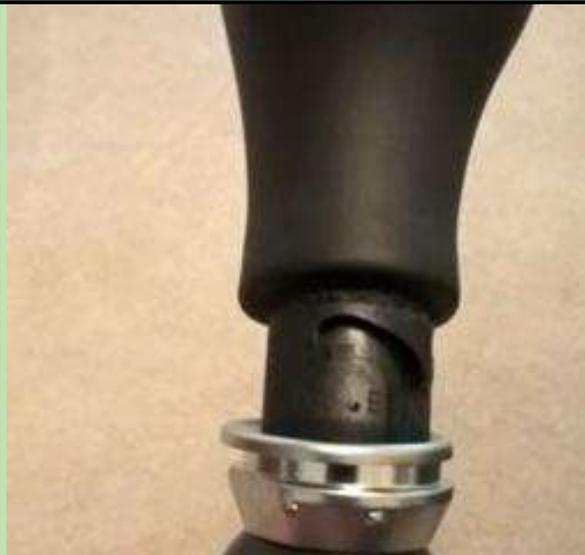
First thing that happened was it appeared very easy to turn the chrome ring! Well no it turned out what I found easy to move was the leather was moving and came loose from the chrome ring!

In fact this is a pic from a poster on the Forum. It shows something similar to what I saw a chrome ring separated from the leather boot! Not the first thing I wanted!

Thank goodness in a post where that happened to someone where members were saying you need to remove the console top to get access than staple the two tighter. In fact looks like two staple holes below the ring slot. I saw what looked like one side of a large staple but it must have fallen down.

Fortunately someone said; instead of all that work why not use Gorilla glue! Gave me an idea, use my favorite adhesive,-5 minute epoxy! Dry fit the parts and the top of the leather boot slipped in the groove fine. Mixed some epoxy and with a tooth pick carefully placed in in the groove and pulled up the leather boot. Left it overnight.

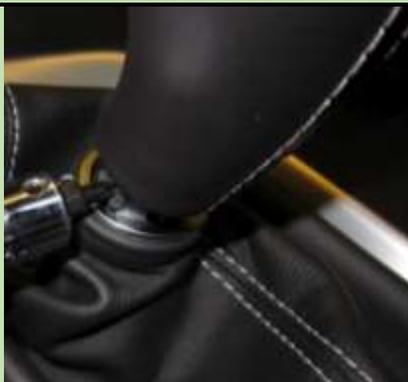
This is from a forum post but what my screw looked like. It required a small #15 Torx bit.

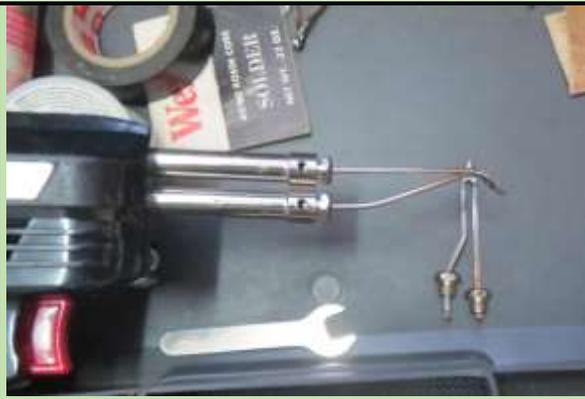
Another pic from a forum post but similar what I did using a Torx bit and a ¼ inch drive ratchet wrench

It looked like the screw was rounding so stopped and bought a new #15 Torx wrench.

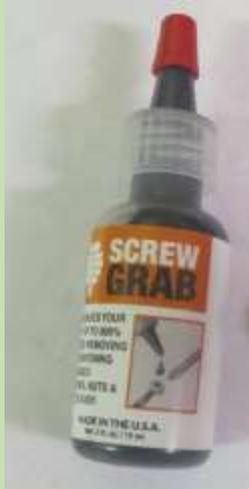
Thinking they may have used a Red type Loctite I readied my soldering iron and shaped the flat tip to fit the screw

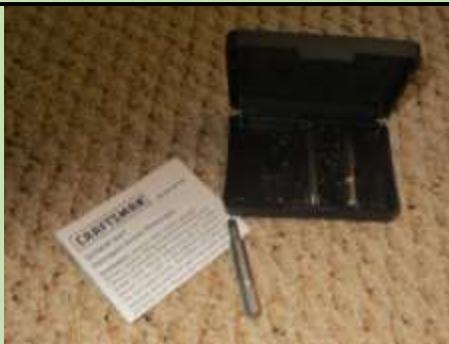
Also bought a product I knew about but had not every used. It is a friction increaser than said it would increase the contact force between a warn screw and the tool!

Tried it with the new Torx bit. The screw (or I thought) made about a 1/2 turn. Encouraging But it would not turn any further. Used the soldering iron for several minutes, no help!

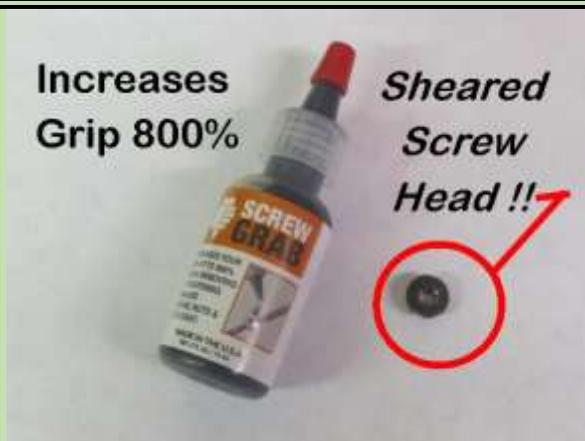
No choice it was not turning so drilled a small hole and used a product called Screw-Out. It is made of hardened steel and has sharp edges that bit into the hole. Still would not budge.

Then placed a drop of this black toothpaste consistence Screw Grip on the Screw-Out!

Movement, but not the screw as hoped! The head sheared from the screw! Screwed!!

Thought even then need to drill out the screw and install a bolt if necessary until the shift kit arrives. When drilling out the screw body realized it was not as long as the new screw provided. There were 4 or 5 threads left in the shifter shaft that were visible and unharmed

It worked, the new Allen screw held firmly. Had some difficulty getting the pins in the chrome ring to slip in both grooves. If one lined up the other was off perhaps 10 degrees. Had to start one pin and then turn the ring forcing the pin in the other groove.

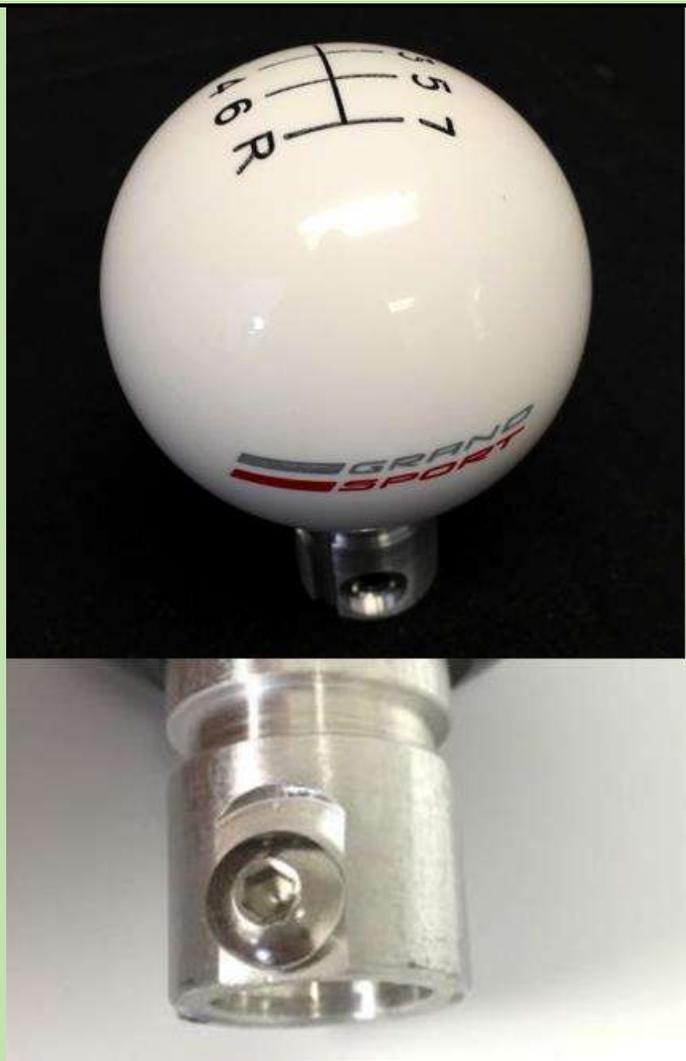
Tried to use one of the "O" Rings but that made it tougher to get both pins up to the top groove. Unlike the OEM knob, there is no slightly raised area to keep the chrome ring from turning. Needed something to keep the chrome ring from turning and keep the pins snug in the groove.

The solution with our white knob was a small amount of white silicone placed in the groove prior to the pins being fully up and then turned. Put some in with a toothpick, then pulled the pins fully up and turned ~90 degrees to have the seams line up properly.

Used some string around the leather boot and let the silicone dry overnight.

Snug as a bug in a rug!

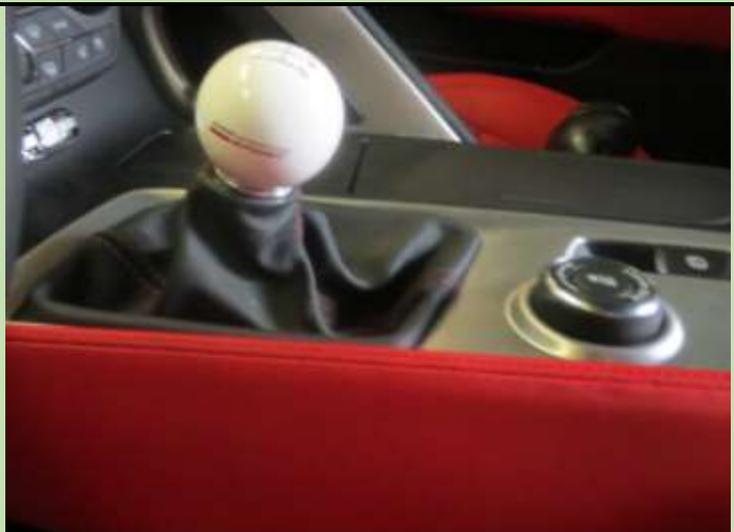
After a Year Had Problem!
Was getting a rattle sound and was concerned it was the aluminum base on the new knob that contacted the metal OEM Shaft.

Decided to get their New Flat Stick that comes with a rubber grommet that replaces the OEM aluminum OEM grommet that is connected from the leather! This is a PDF of that install:

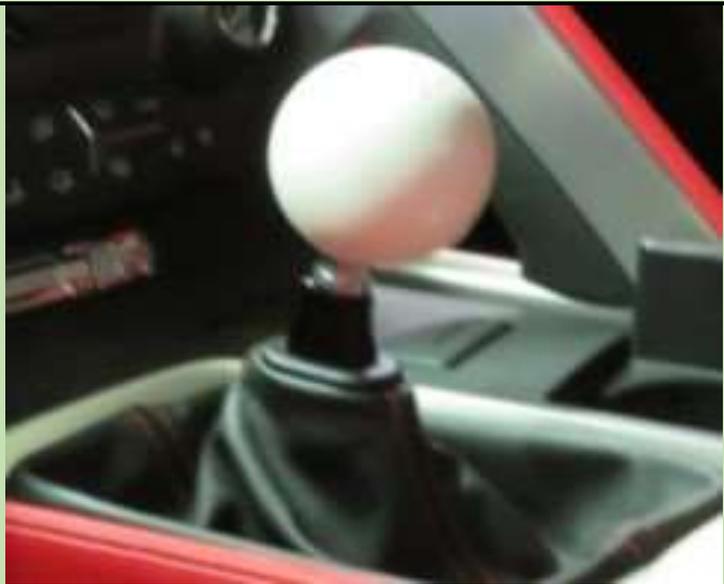
Confirmed in conversation with George from MGW Shifters.

Was concerned that removing the knob required dealing with the glued leather to OEM grommet and then the few threads holding the screw! If a problem I would be faced with what I was planning when I had the issues-buying and installing a MGW shifter!
